BOEING
STRESS
CORROSION
TESTING
OF HIGH STRENGTH
STEELS

INVESTIGATION OF SUSCEPTIBILITY OF HIGH STRENGTH MARTENSITIC STEEL
ALLOYS TO STRESS CORROSION

TECHNICAL DOCUMENTARY REPORT NO. ASD-TDR-62-876
September 1962

(Prepared under Contract No. AF 33(616)-7839 by The Boeing Company,
Transport Division, Renton, Washington; Gary A. Dreyer, Author)

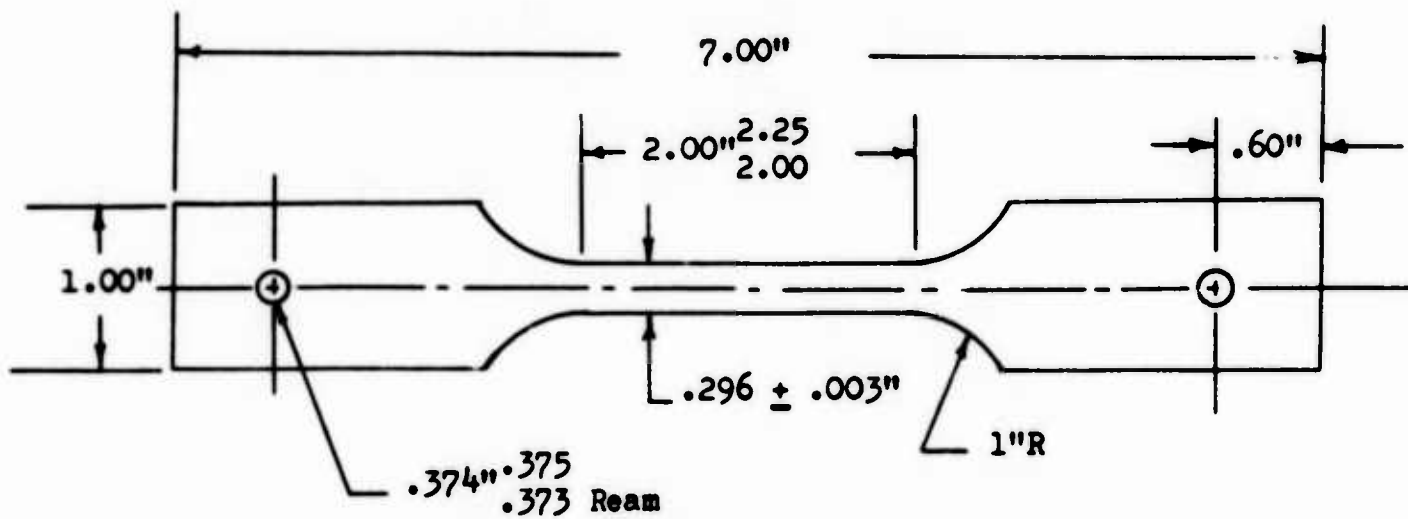
FIGURE 8
Sheet Stress Corrosion Specimen

The sheet stress corrosion specimen and stressing jig are shown in Figures 8 and 9. Smooth and notched tensile specimen configurations are illustrated in Figures 10 and 11. The notched tensile configuration is the same as that used in a study of AM 350 sheet (4) under a separate Air Force contract at Michigan State University.

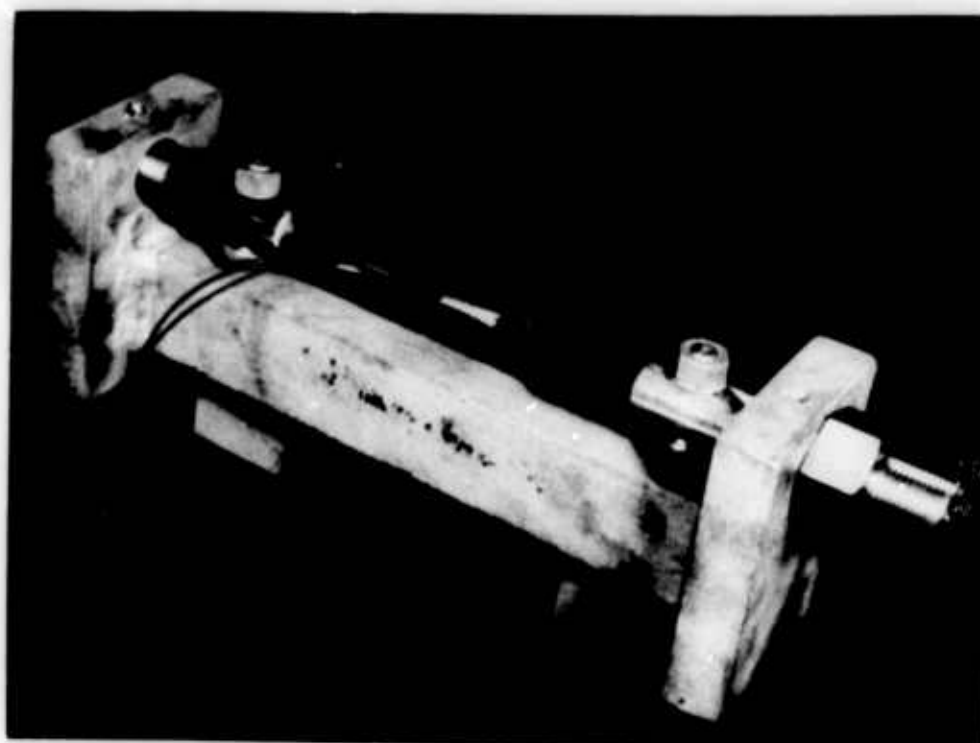
FIGURE 9
Sheet Stress Corrosion Test Jig

Sheet stress corrosion specimens were stressed by applying an axial tension load. The loading jig is shown in Figure 9. The stress level in all sheet specimens was attained using strain gauges.

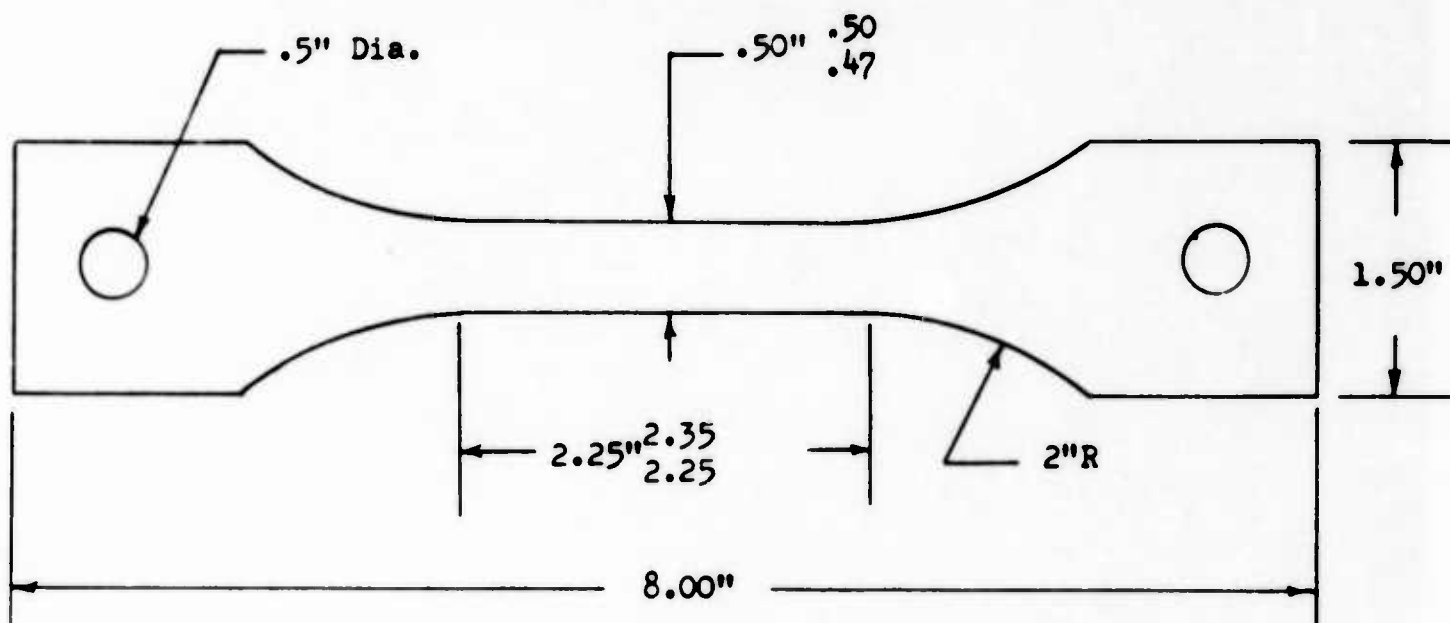
FIGURE 10

Sheet Smooth Tensile Specimen

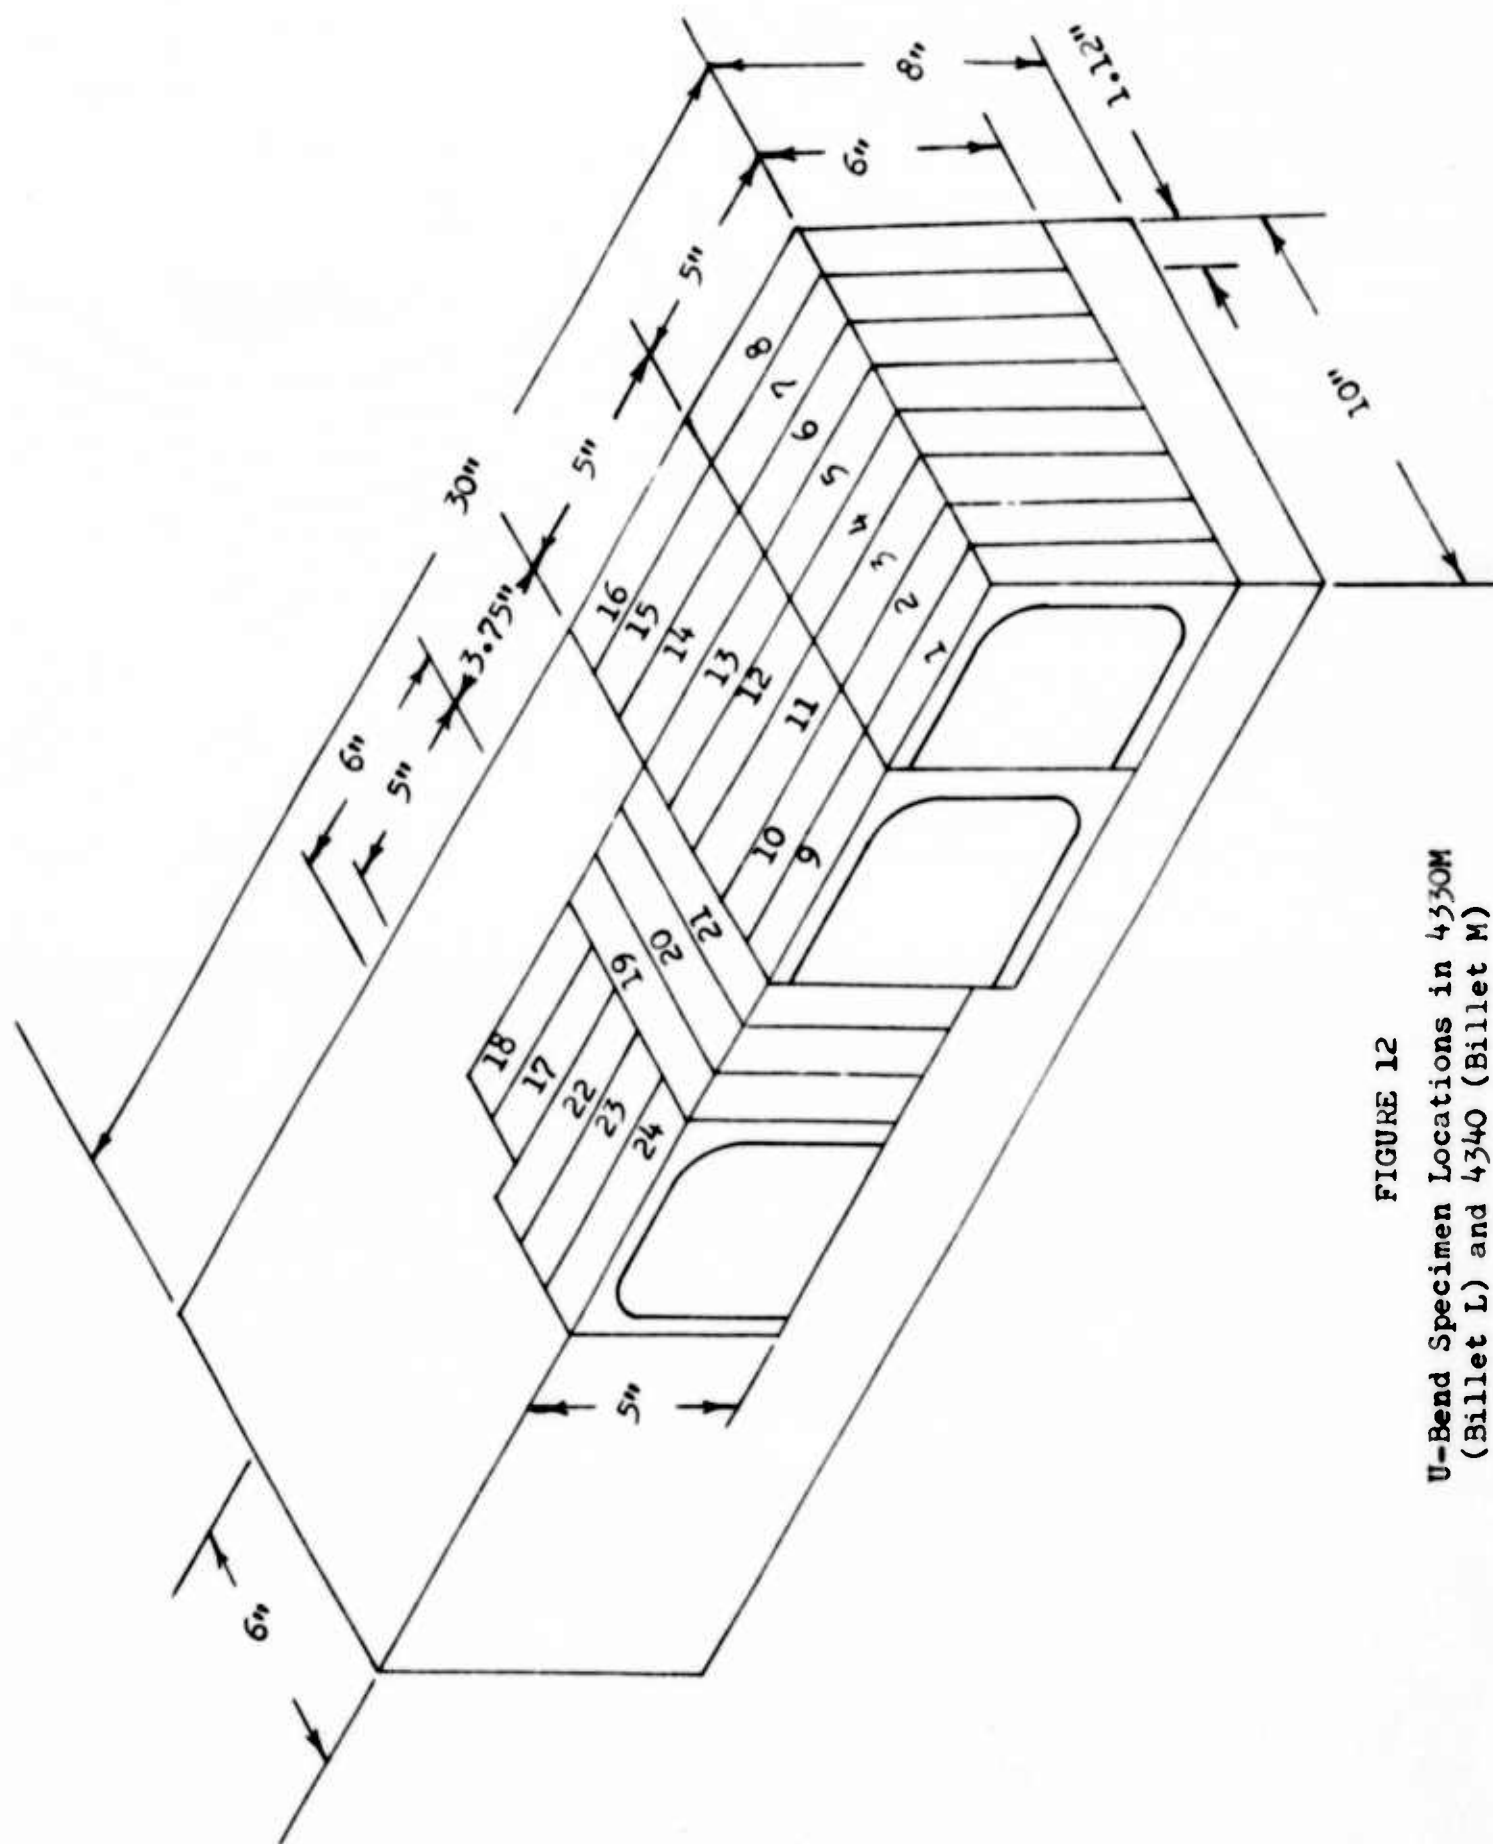
FIGURE 12
U-Bend Specimen Locations in 4330M
(Billet L) and 4340 (Billet M)

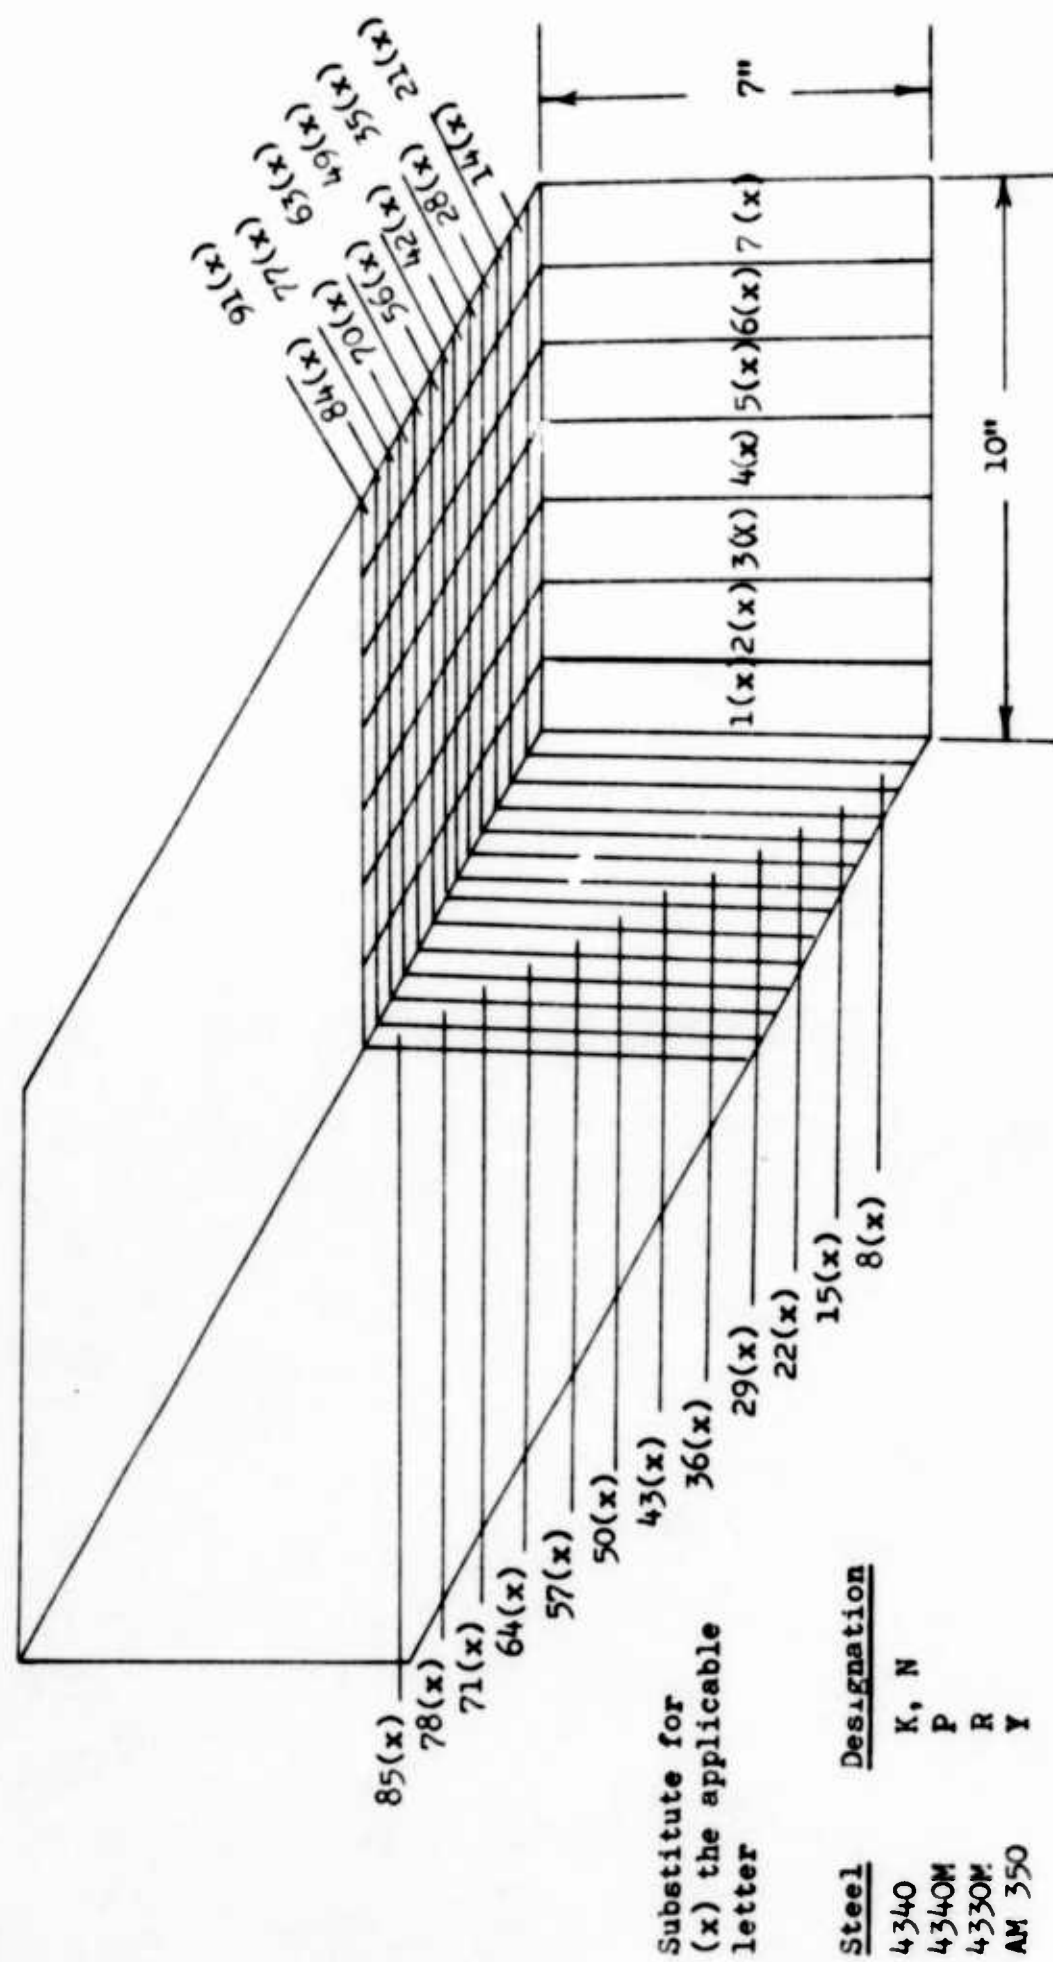
FIGURE 13. U-Bend Specimen Locations in 4340 (Billets K and N), 4340M (Billet P), 4330M (Billet R) and AM 350 (Billet Y)

The effect of strength level on stress corrosion cracking susceptibility was determined for 4340, 4340M, 4330M and H-11 steels. All U-bend smooth and notched tensile specimens were removed from the short transverse grain direction of each billet. All specimen locations are shown in Figures 13 through 17.

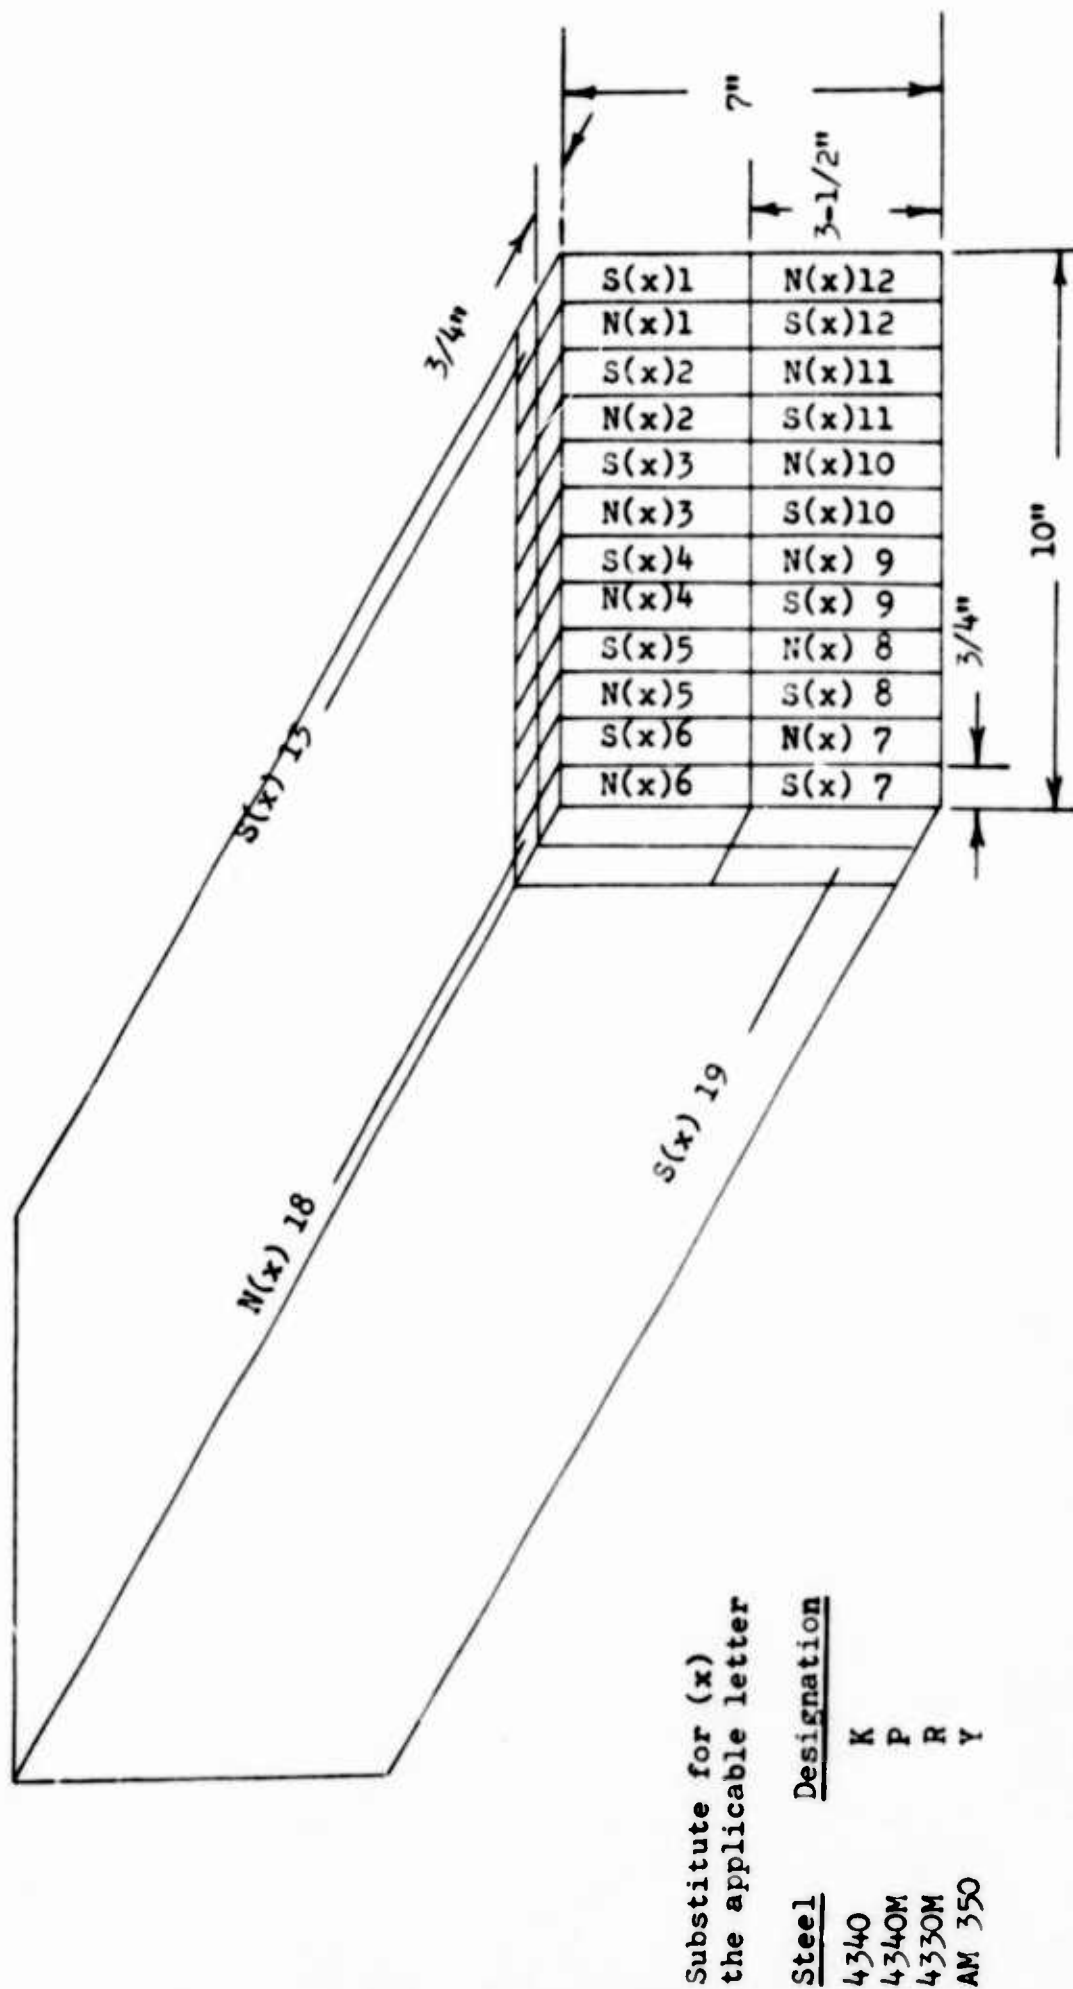
FIGURE 14. Tensile Specimen Locations in 4340 (Billet K), 4340M (Billet P), 4330M (Billet R), AM 350 (Billet Y)

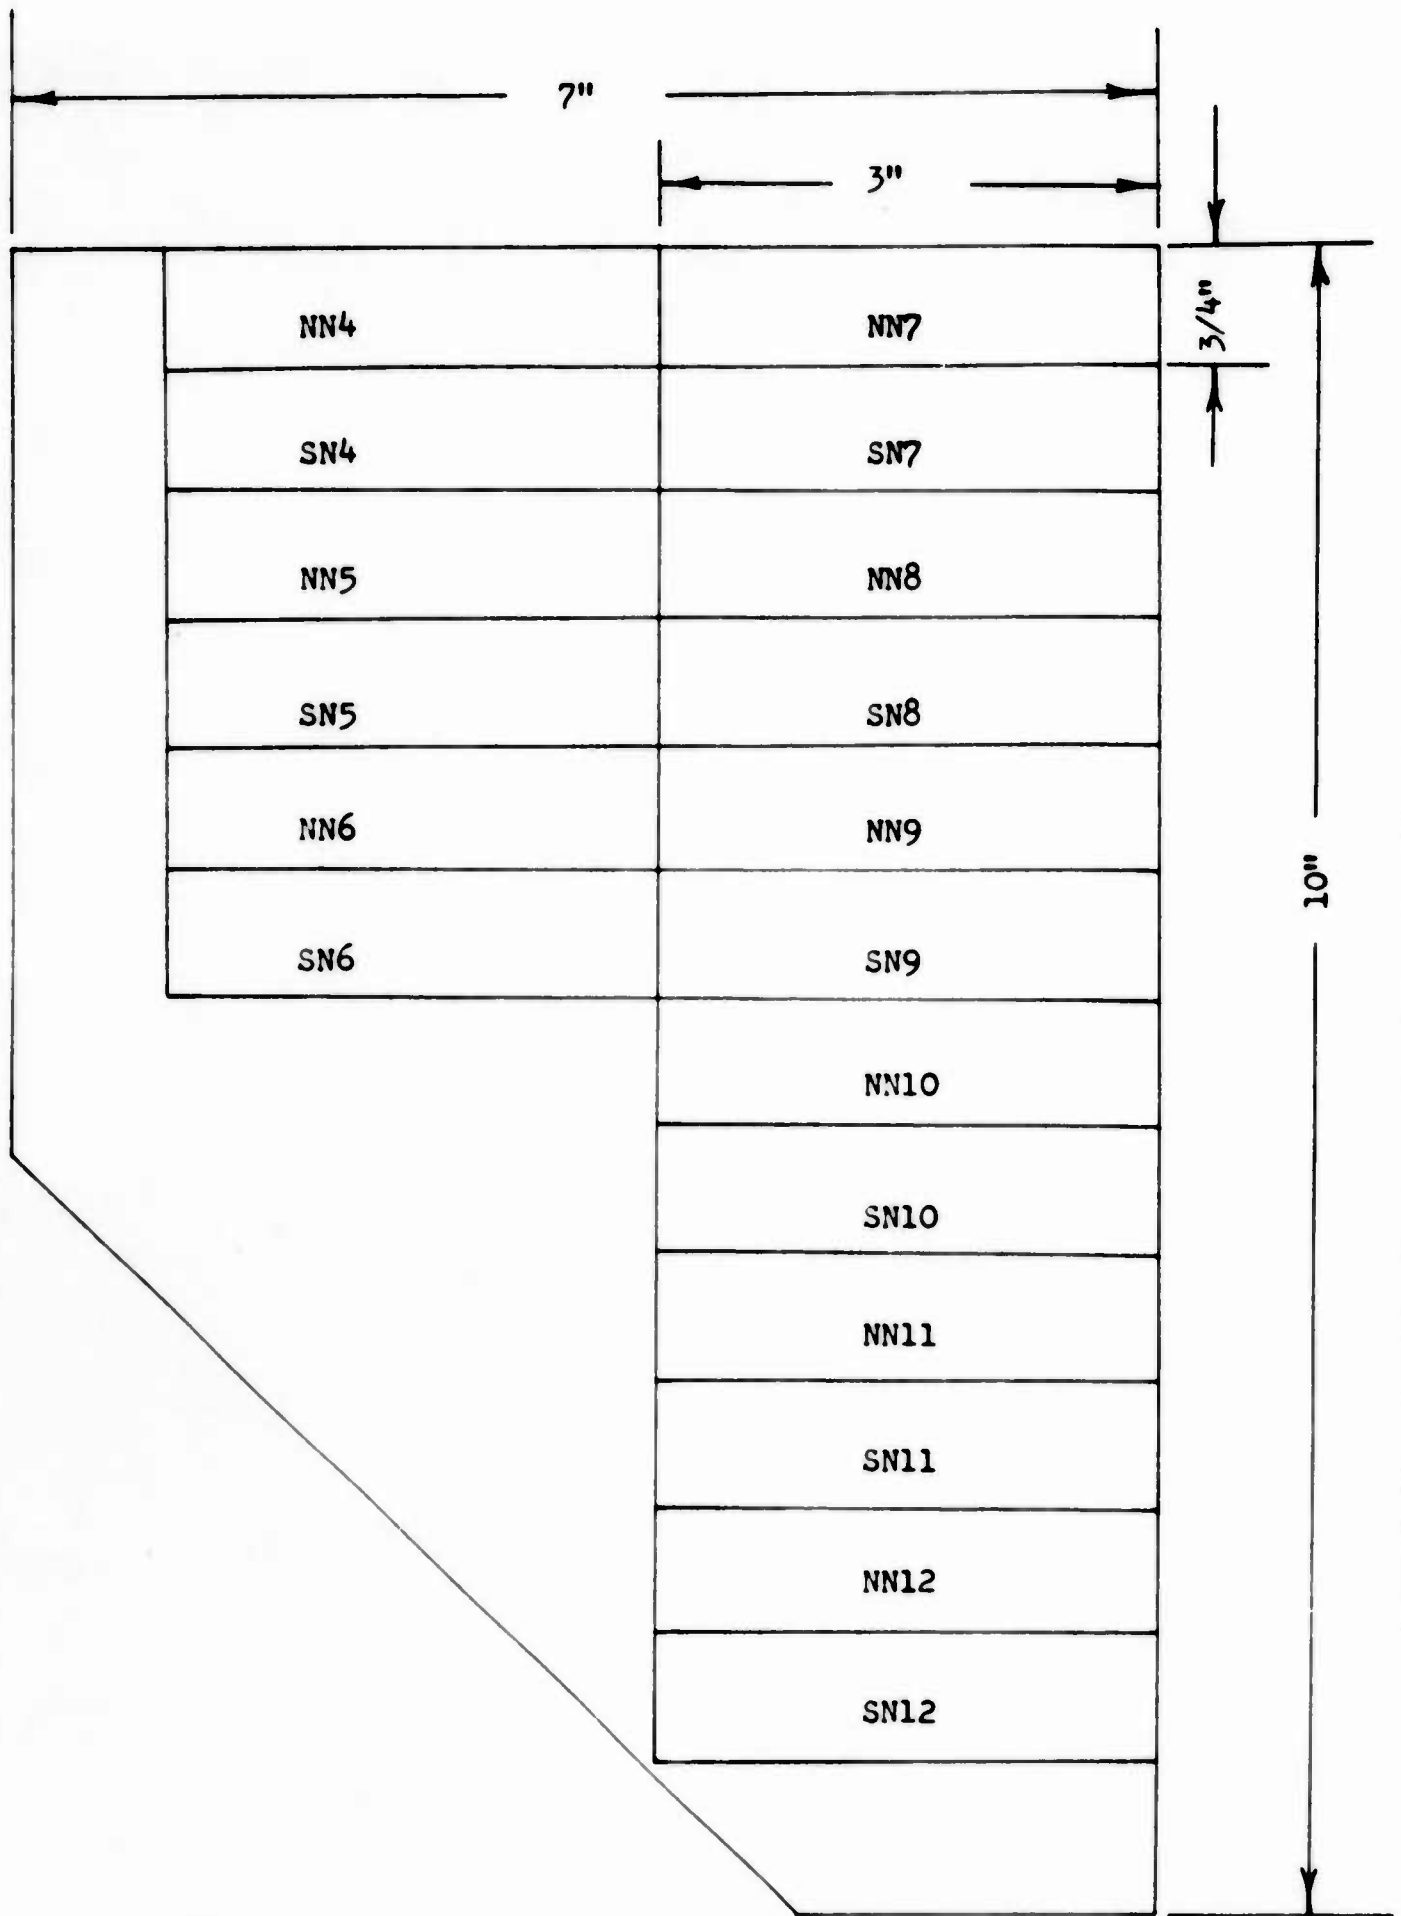
Figure 15. Tensile Specimen Locations in 4340 (Billet N)

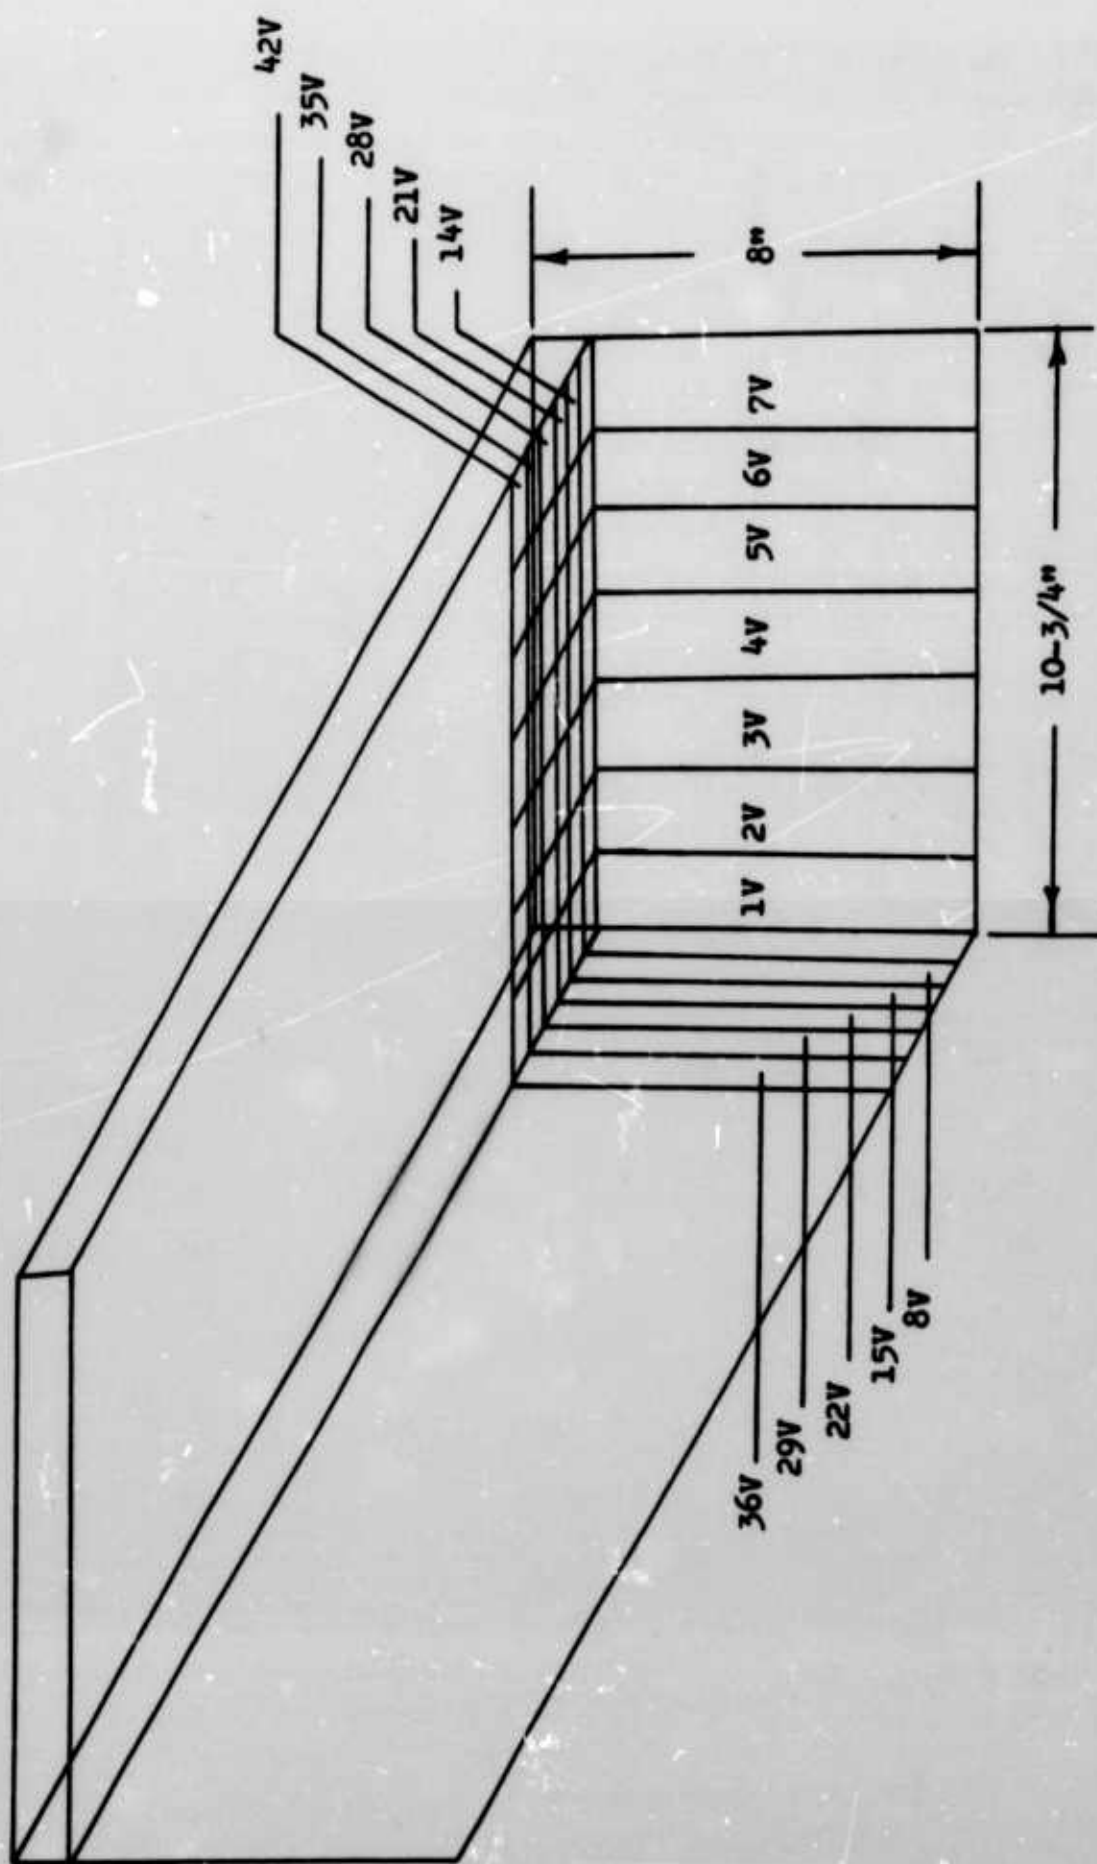
FIGURE 16. U-Bend Specimen Locations in H-11 (Billet V)

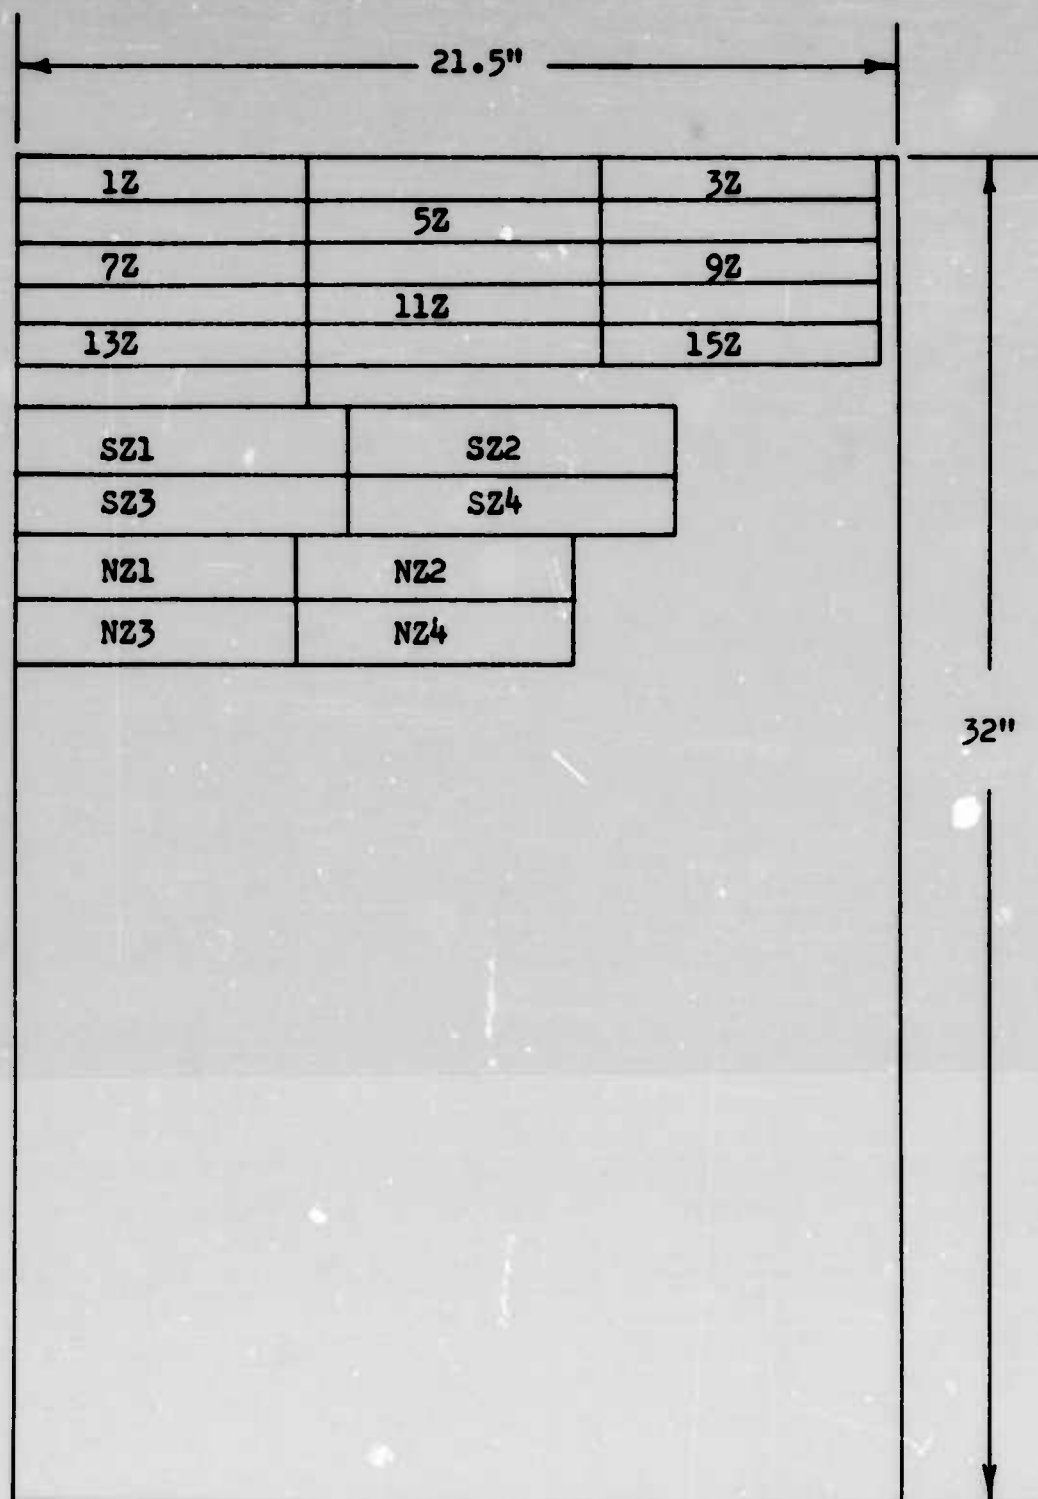
FIGURE 21
Stress Corrosion and Tensile Specimen
Locations in AM 350 (Sheet 2)

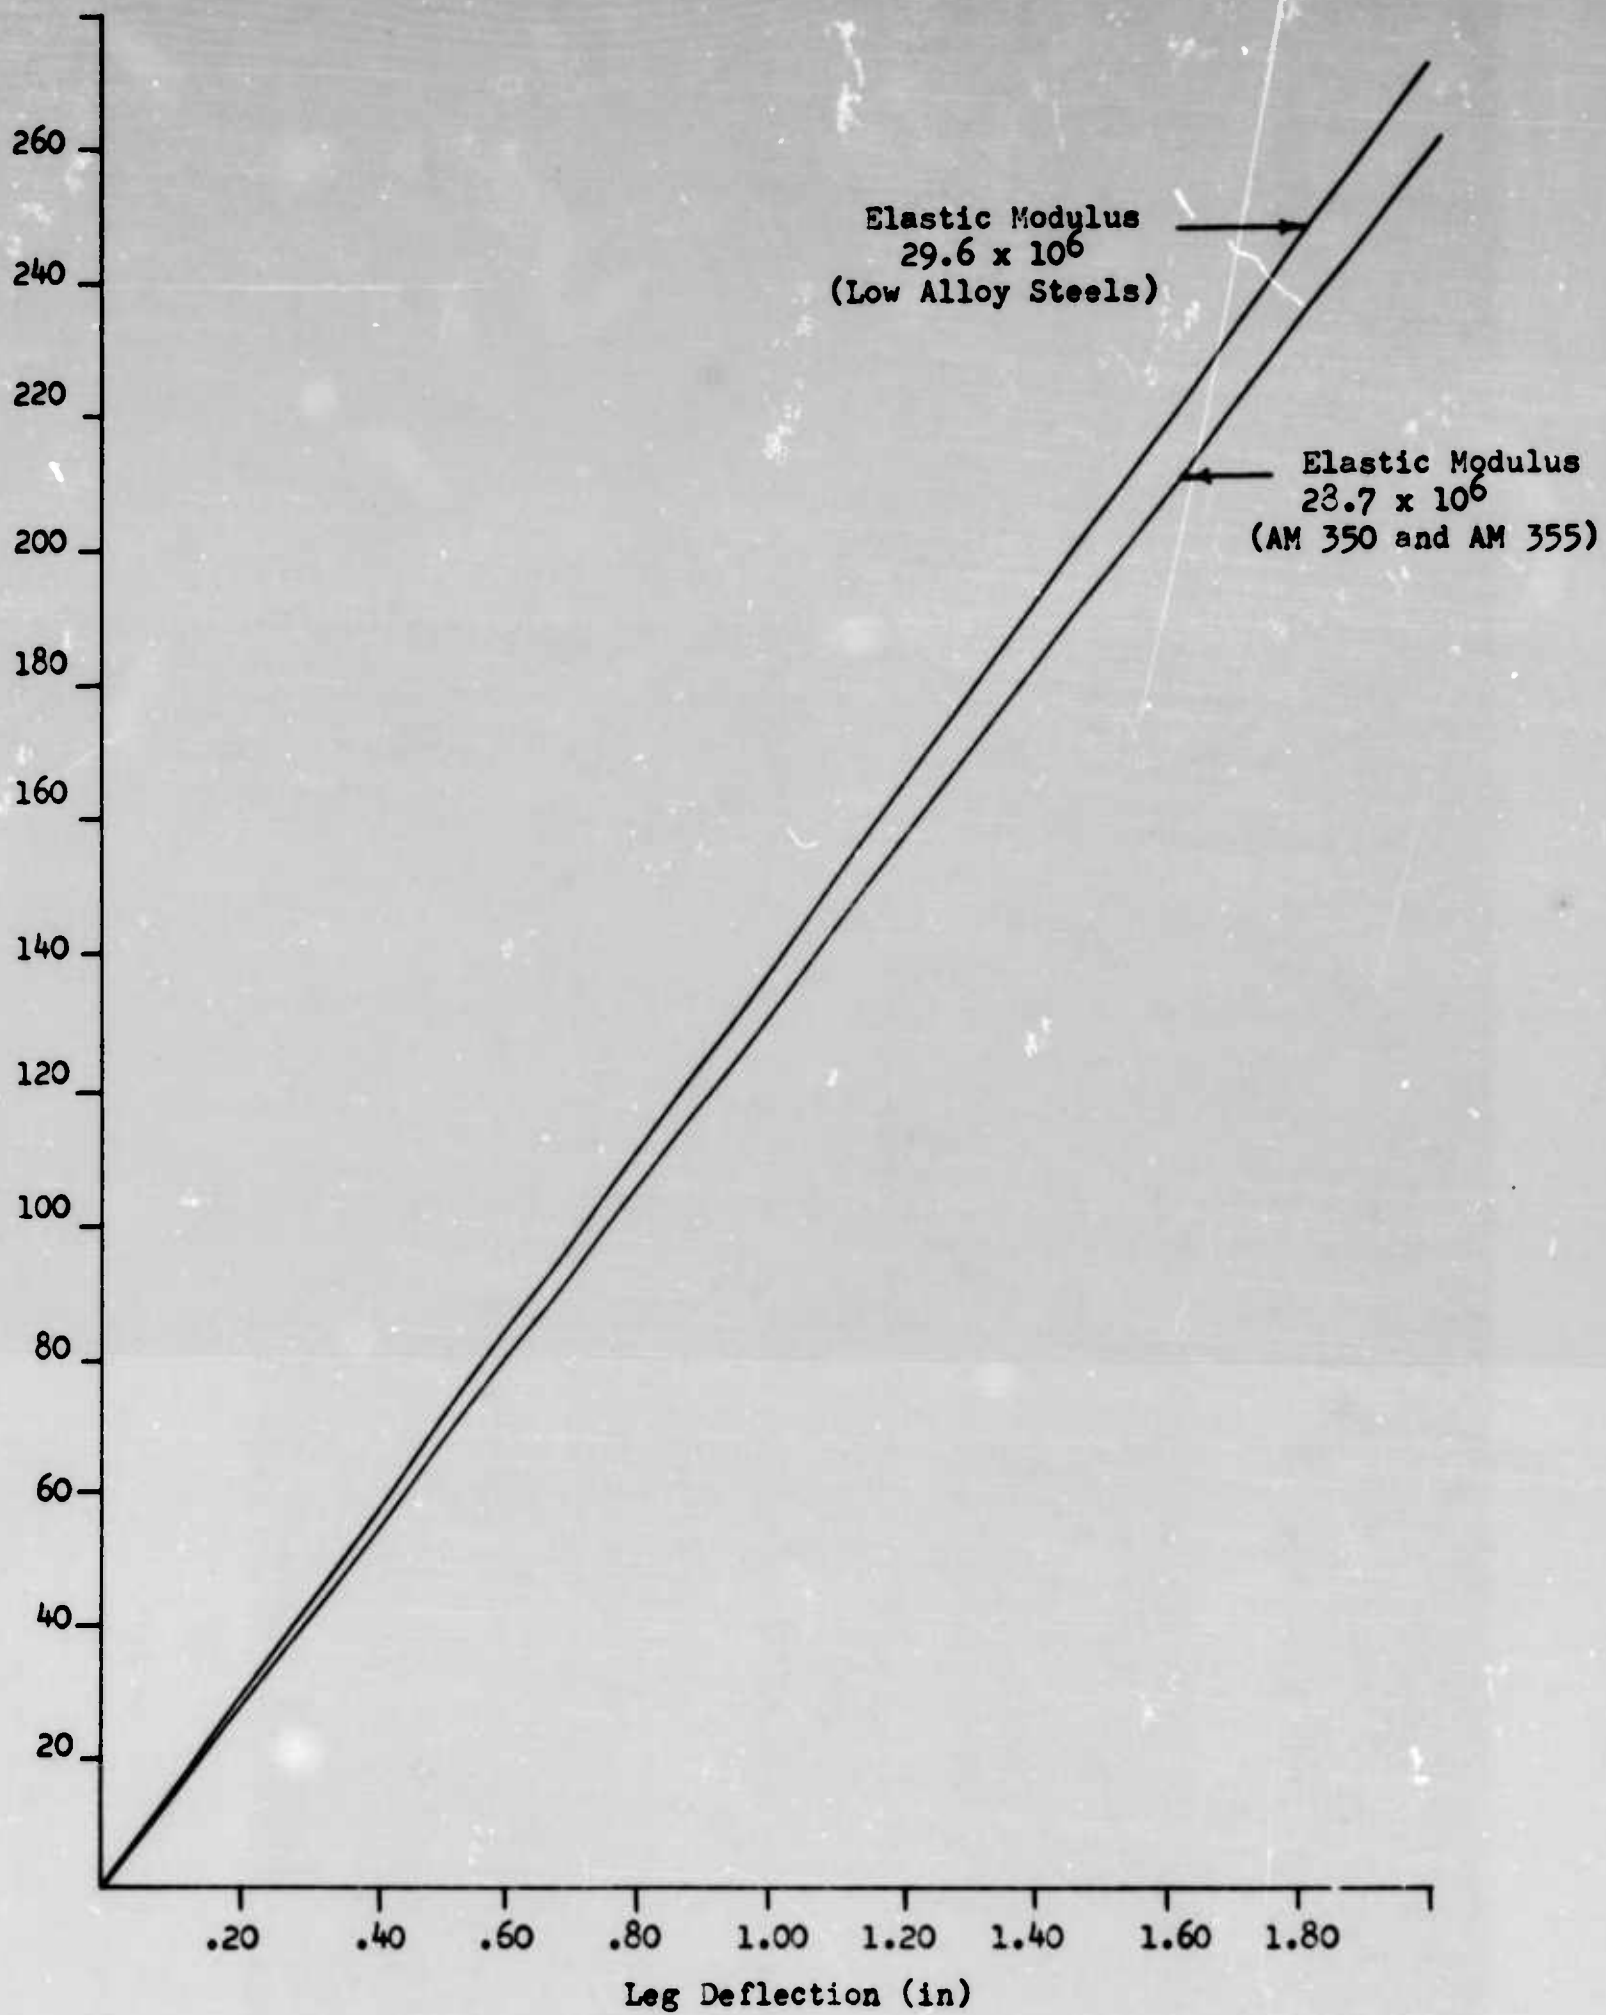
FIGURE 22. Stress Level as Function of U-Bend Specimen Leg Deflection

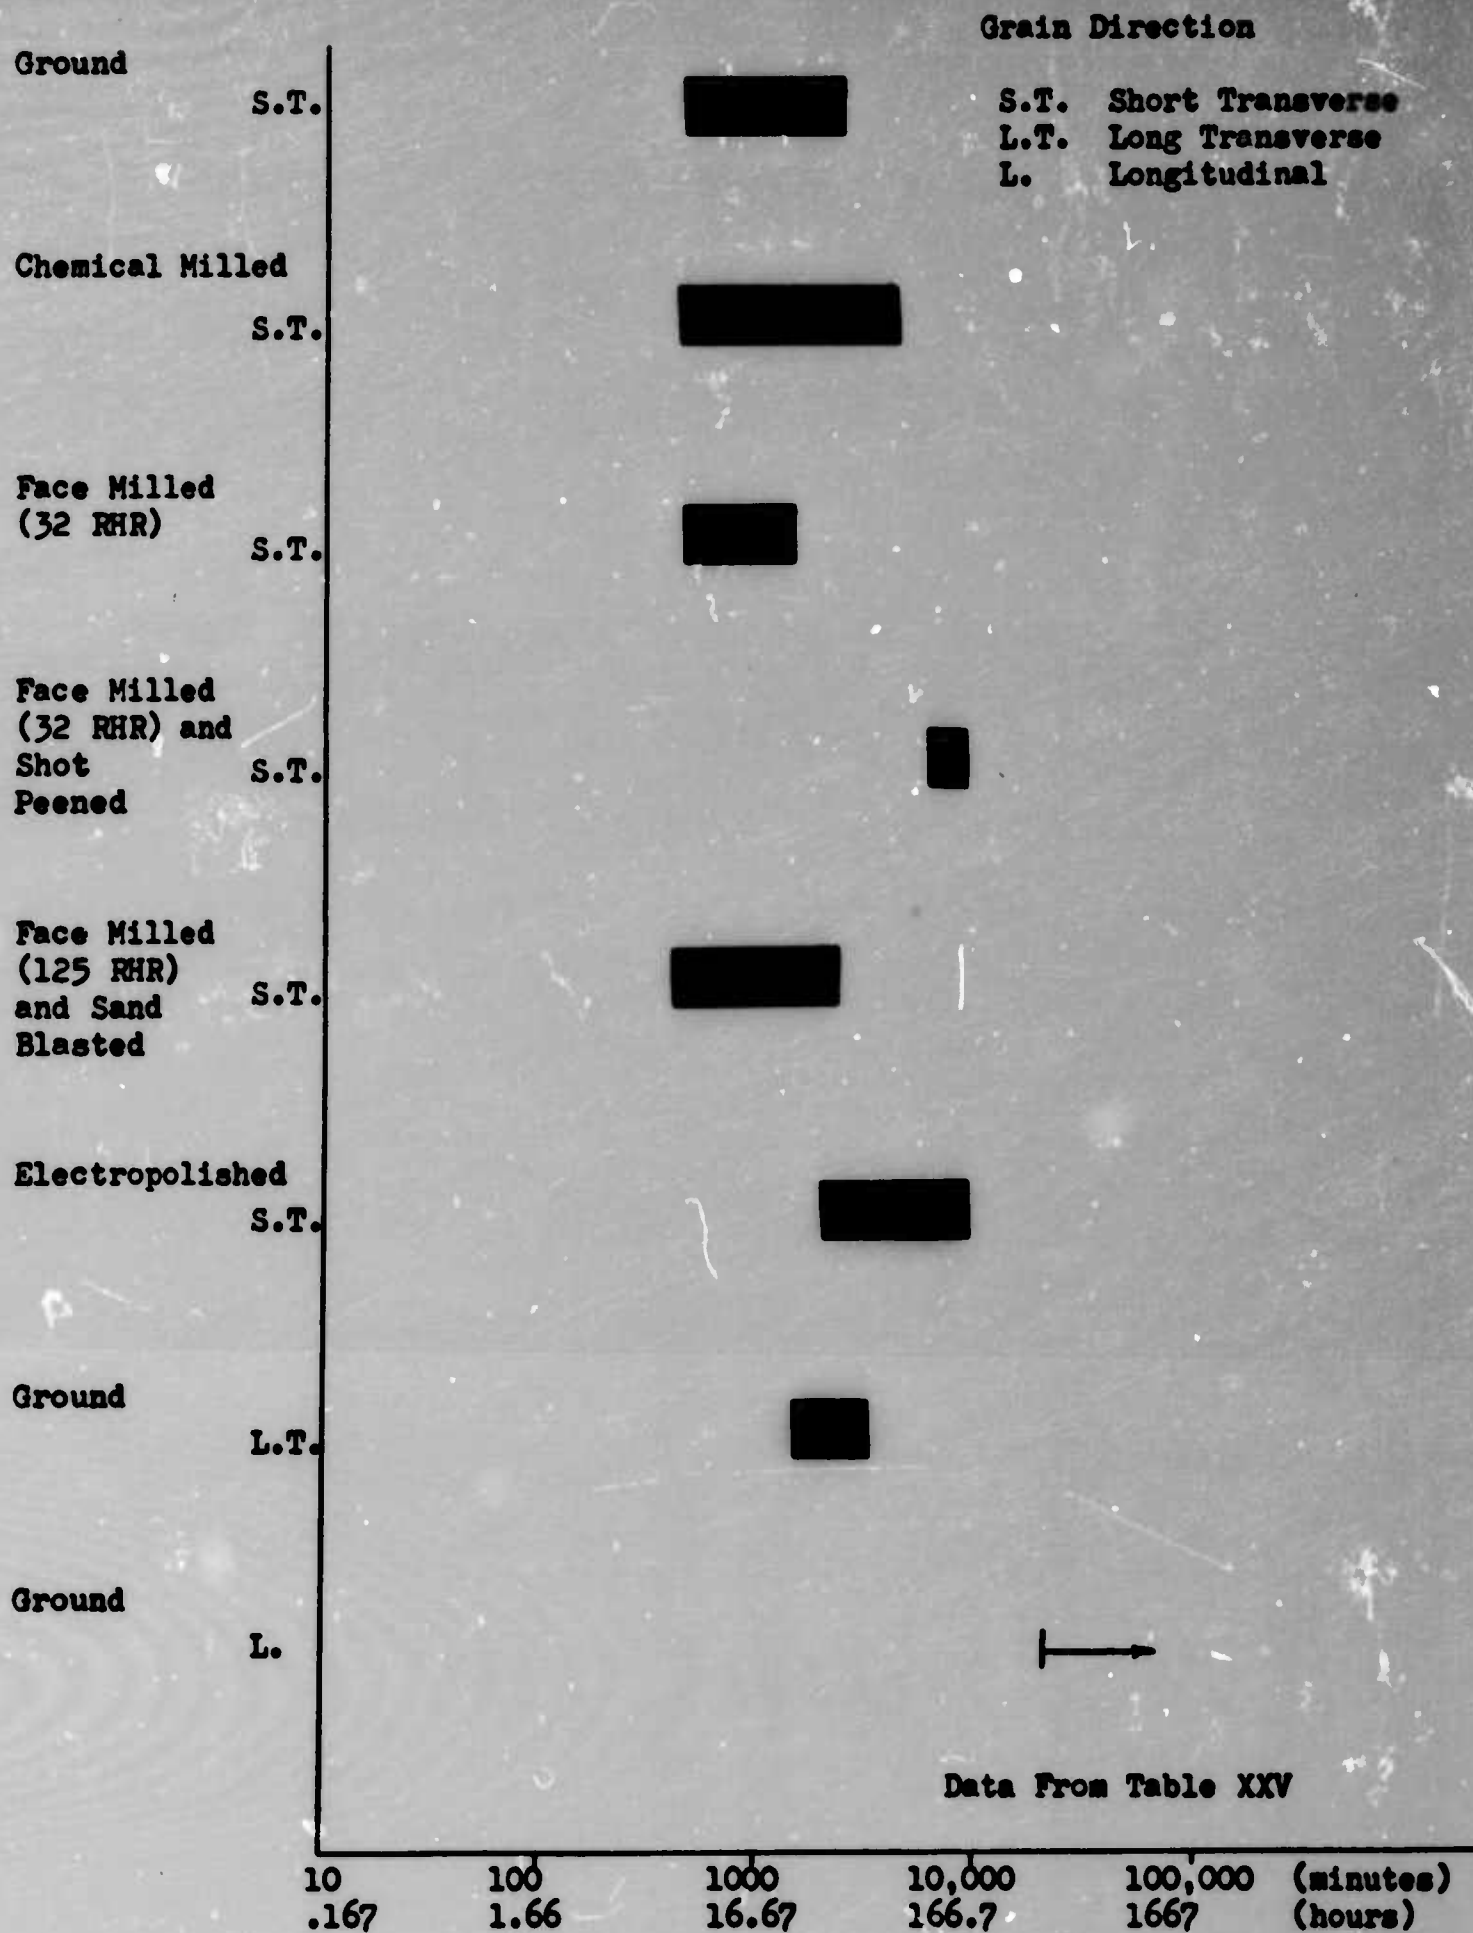
FIGURE 30. Range of Failure Times of 4330M (Billet L) U-Bend Specimens After Receiving Various Surface Finishes
